Coating for the Protection of Process Equipment Operating at Elevated Temperatures

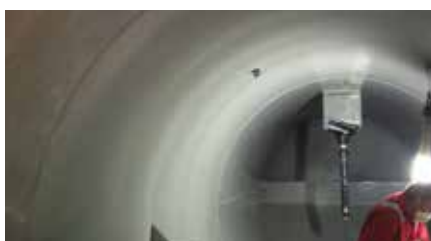
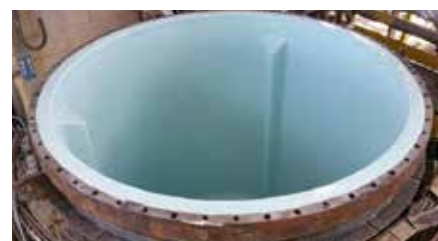
The light colours of Belzona 1593 allow easy visual inspection in vessels.

- Boiler vessels
- Condensers
- Heat exchangers
- Flare knock-out vessels and evaporators
- Separators
